# Manhole Inspection Summary

Manhole # S43GG\_018MH

Insp Date: **7/6/09 2:08 PM**

**Location** Address: **REAR OF 1229 BROADWAY AVE** Cross Street: **REGISTER ST**

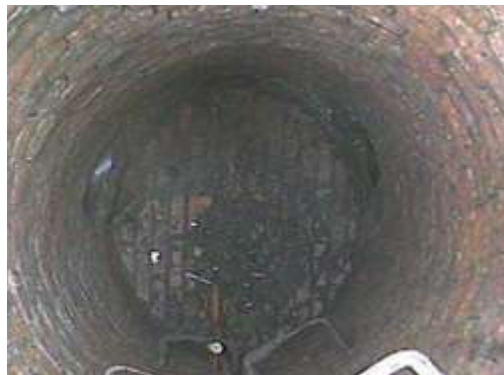
Top View

Comments **POSSIBLE ILLICIT CONNECTION - SEE PHOTO CONNECTION @ 3 O'CLOCK IS OUTGOING**

POSSIBLE ILLICIT CONNECTION

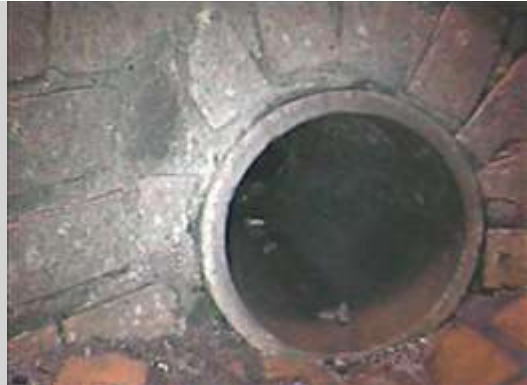
12 O'Clock Outflow

8 in. Circular Gravity Sewer  
Pipe Out @ 12 O'Clock

Infiltration: **None** Pipe Seal Cond: **Sound**

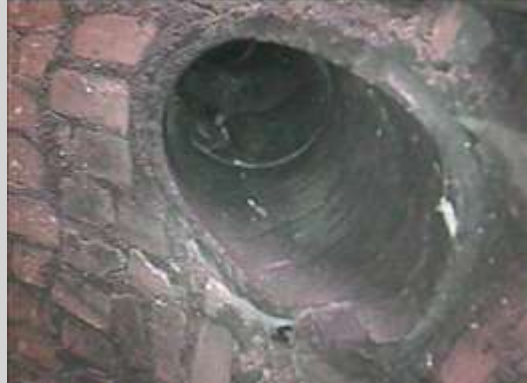
7 O'Clock Inflow

Pipe In @ 7 O'Clock

Infiltration: **None** Pipe Seal Cond: **Sound**
